PHASE I ENVIRONMENTAL SITE ASSESSMENT (ESA) REPORT

EATON SUGAR BEET FACTORY
TARGETED BROWNFIELDS ASSESSMENT (TBA)
Eaton, Weld County, Colorado

January 14, 2010

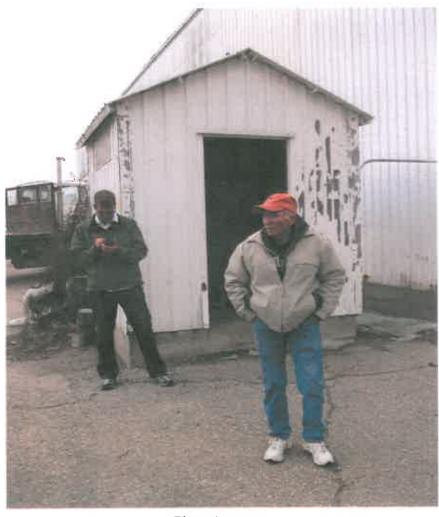
Photo 1 Closed historic process water well, looking west. Pictured Boyd Foster, former super attendant of the Eaton Great Western Sugar Factory (GWSF) and Jeremiah Ervin, START.

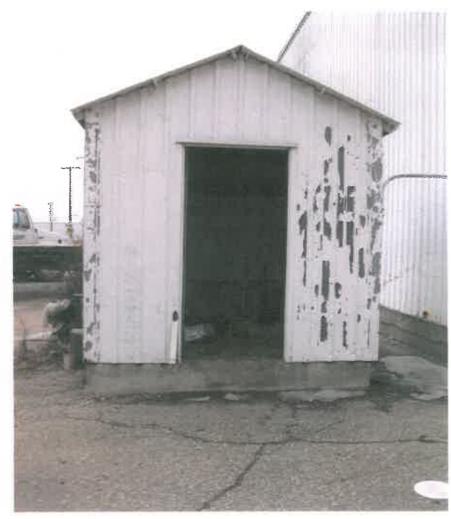
Photo 2 Closed historic process water well, looking to the west.

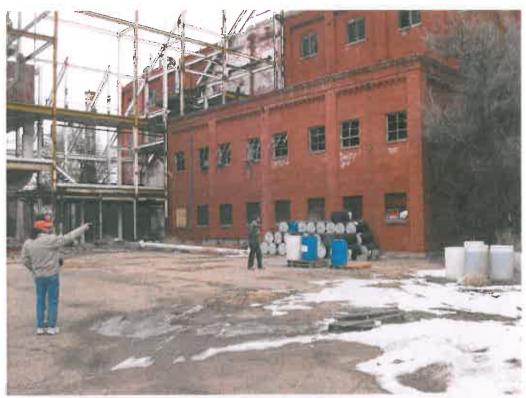
Photo 3

The main building of GWSF, looking northeast. Agland Inc., Drums stored on property boundary against GWSF main building. Pictured Boyd Foster and Jeremiah Ervin.

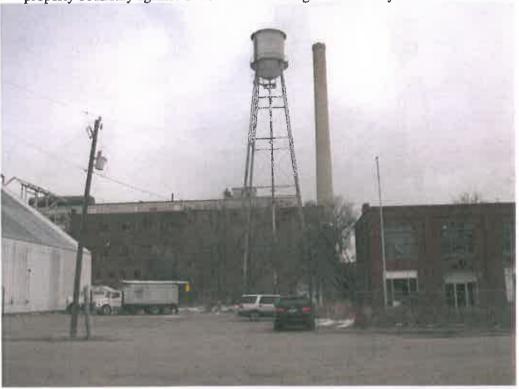
Photo 4
GWSF main building and office, looking east. Showing graffiti and broken windows on the buildings upper floors

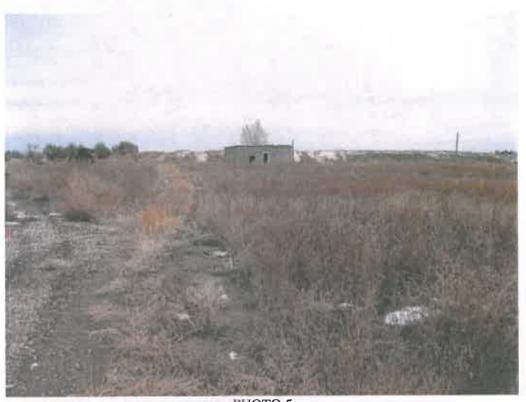
PHOTO 5 Lime pile, in the distance behind the factory building, looking northeast.

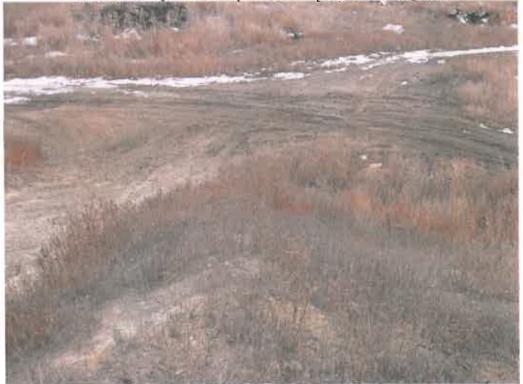
PHOTO 8

Tire tracks in the snow to show recent access to the lime pile area for recreational bicycling.

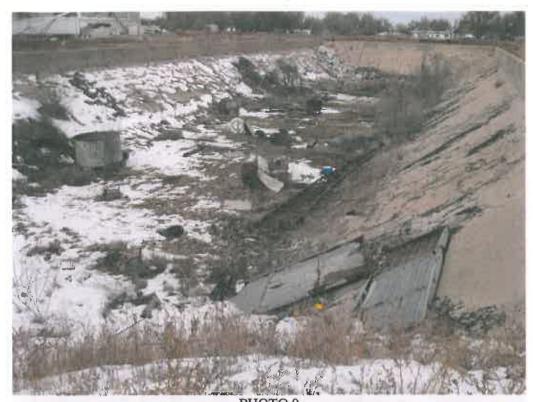
PHOTO 9
Historic location of coal for the GWSF, looking south. Notice the scrap metal and trash on site.

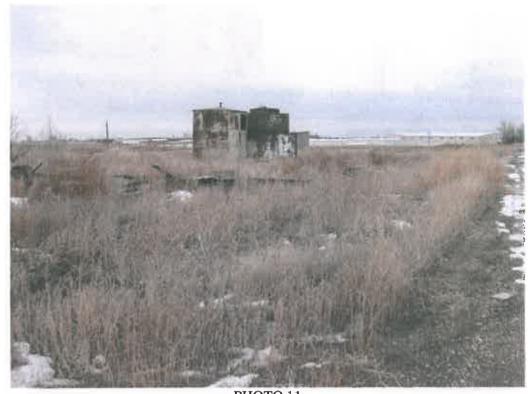
PHOTO 11

Trash and junk metal dispersed on the east side of the GWSF main building

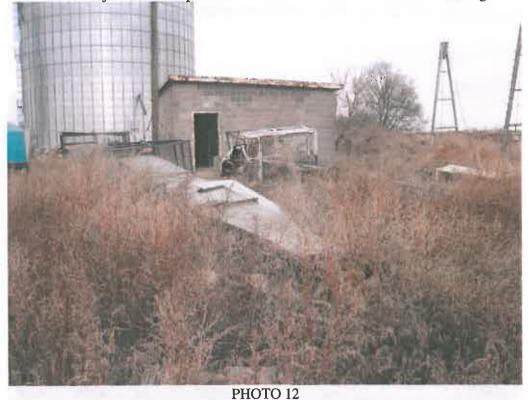
Trash and junk metal on the north side of the GWSF main building, looking north.

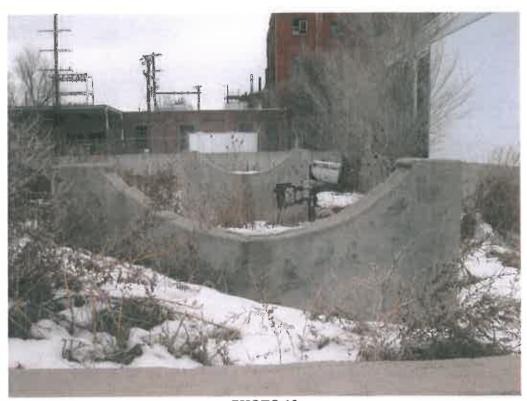
PHOTO 13
Historic location of an above ground storage tank, approximately 10,000 gallon in size (fuel oil), looking to the east. Notice cement containment.

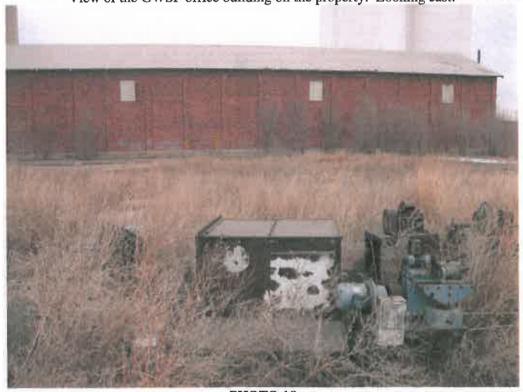
PHOTO 18
Trash in front of GWSF sugar-beet warehouse, looking to the east.

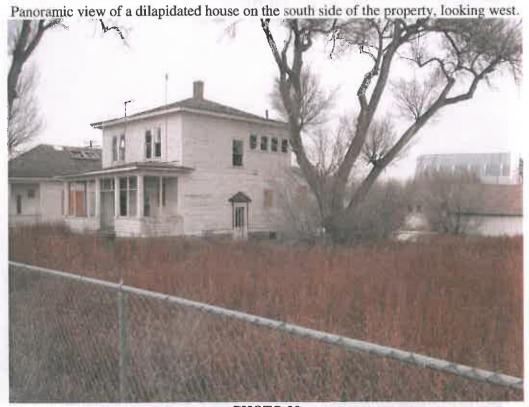
PHOTO 20

Panoramic view of a dilapidated house on the south side of the property, looking northwest.

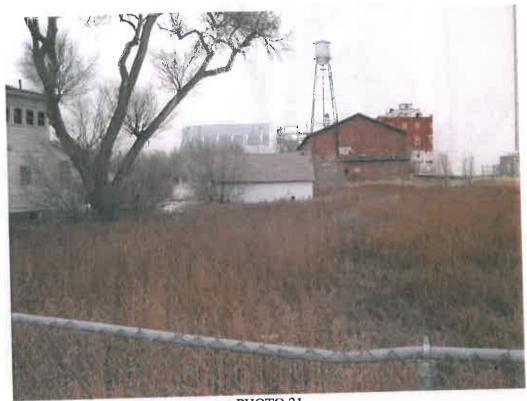
PHOTO 21
Panoramic view of an unattached garage on the south side of the property, looking northwest.
